**MITCHELL PARK HORTICULTURAL CONSERVATORY  
DOMES  
Peer Review**

**Milwaukee, Wisconsin**

**Final Report**

WJE No. 2016.2700

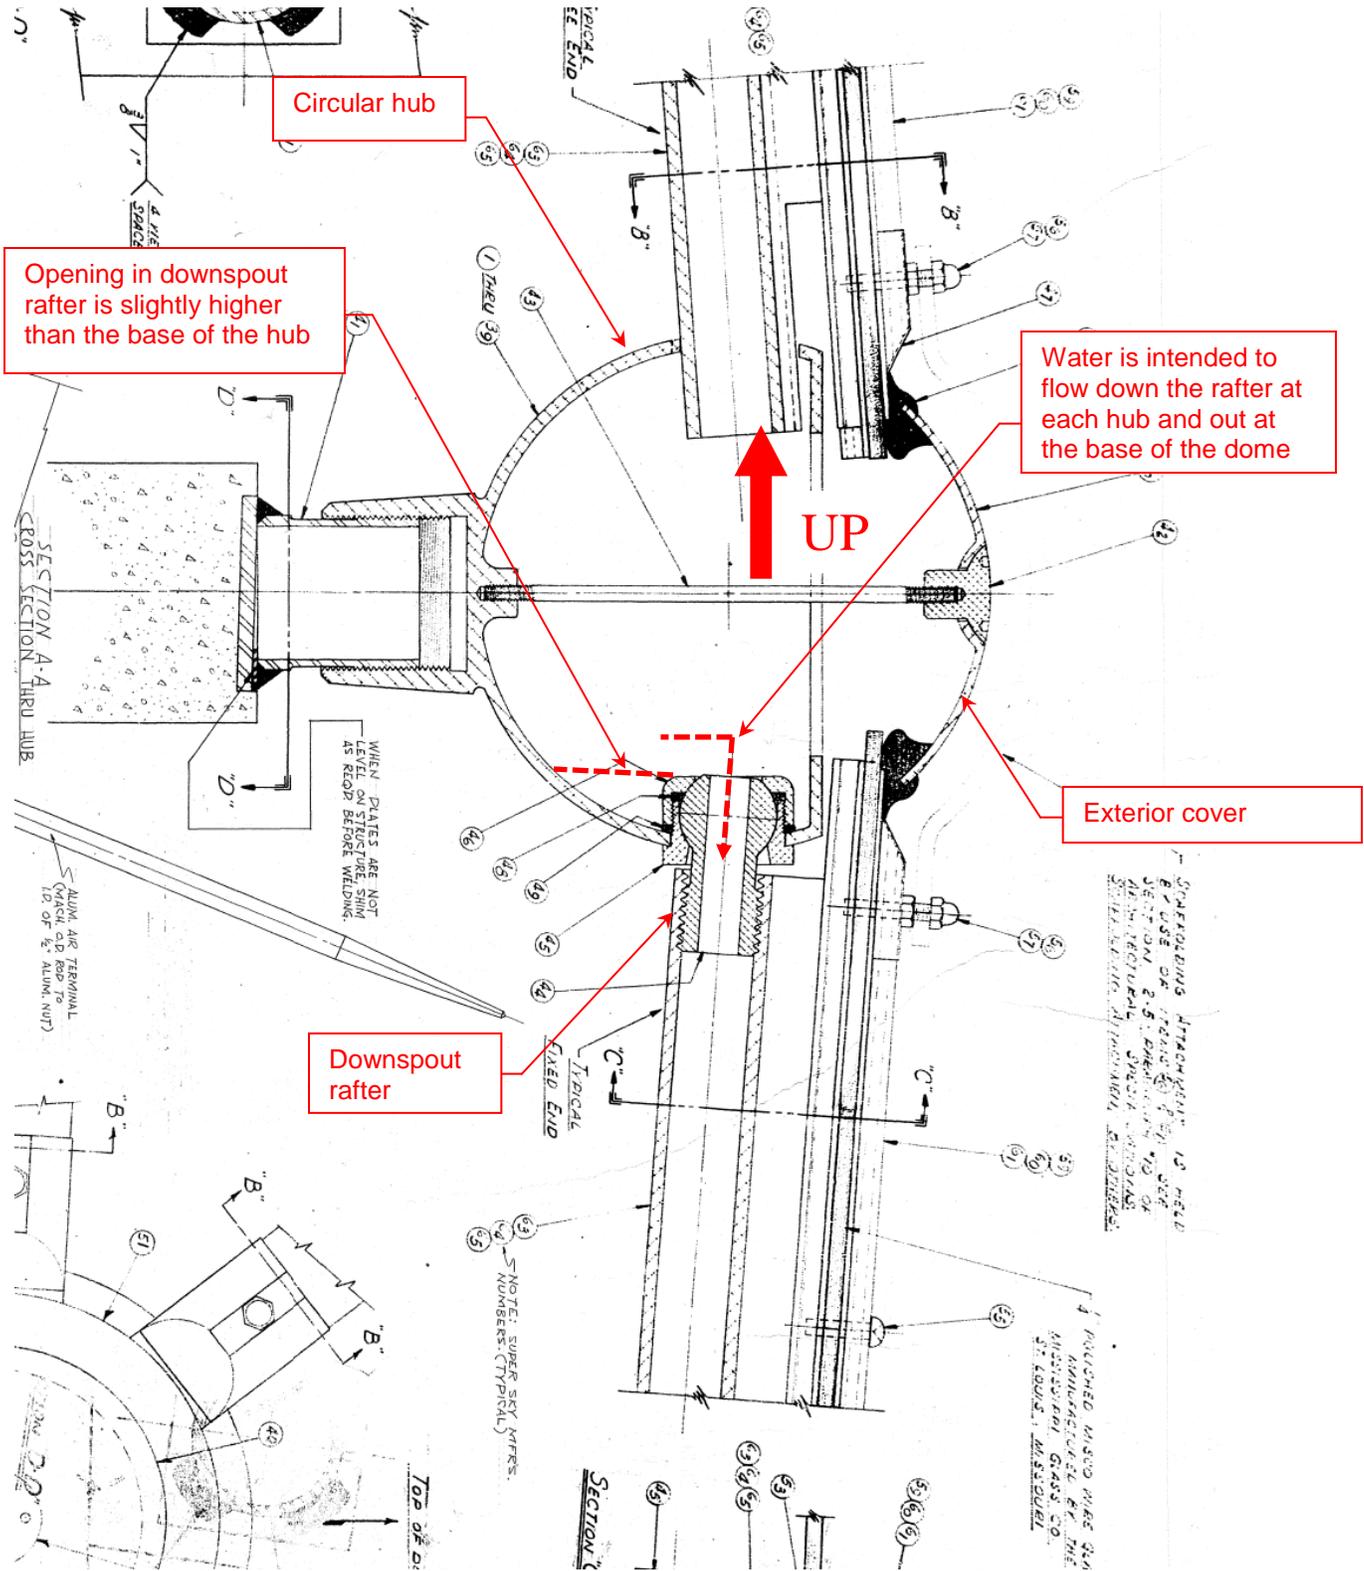
Figure 9. Section through hub from original drawings showing hub cladding drainage system

- GRAEF reported that water leakage throughout the domes has historically been a problem and still remains an ongoing issue. GRAEF reported that water was observed sitting in the hub and not allowed to drain. They attribute this problem as due to the fact that the downspout rafter extends higher than the base of the hub (see Figure 9).

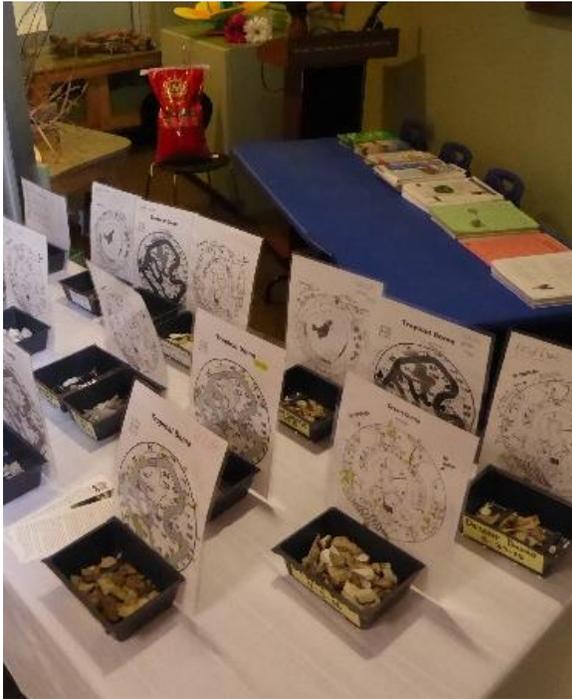
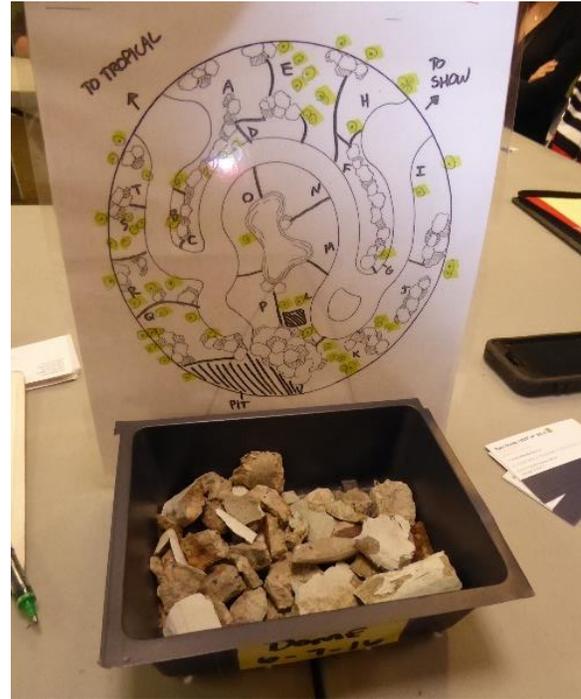
Figure 10. Fragments of concrete collected by Milwaukee County Parks staff

Figure 11. Close-up of fragments of concrete collected by Milwaukee County Parks staff

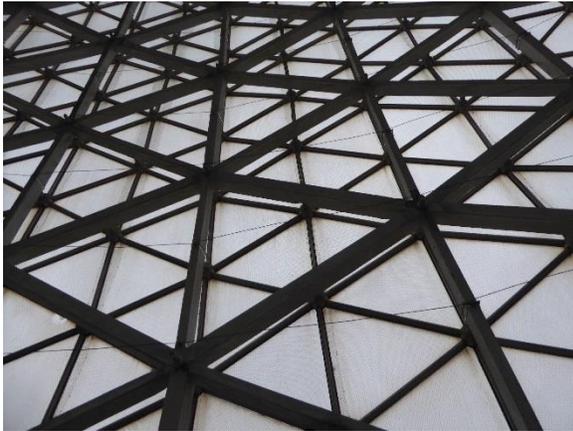
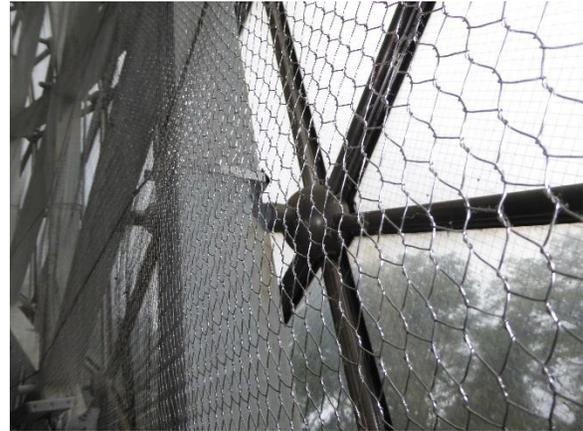
1. Mesh netting secured to the precast framing with cables was observed in the Show Dome (Figures 12 and 13). The netting was in the process of being installed in the Arid Dome.

*Figure 12. Netting and cables in Show Dome*

*Figure 13. Close-up of netting in Show Dome*

- The wire mesh could be removed after the repairs are completed to address water infiltration and spalling at embedded plates. Removing the wire mesh would require regular inspections and maintenance repairs to be completed as necessary. However, the mesh does provide a safety barrier against spalling concrete that has occurred in the domes.

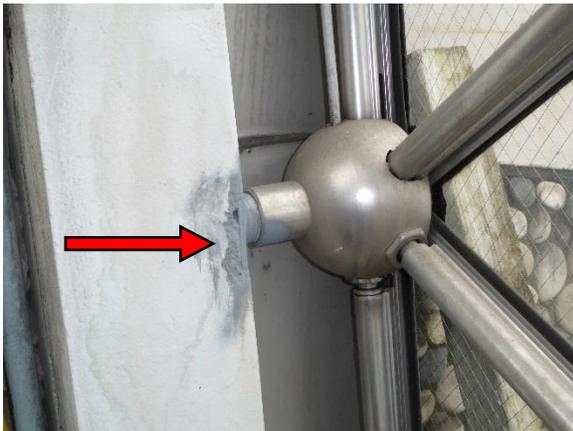
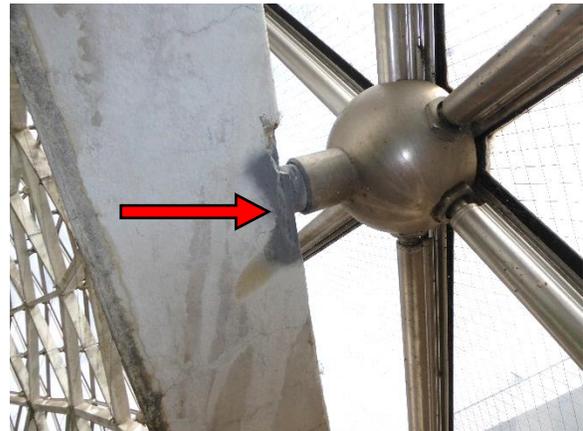
3. Concrete spalls had been removed at several embedded connections where the hub from the glass cladding is supported by the precast framing (Figures 14 and 15). The embedded plate was painted at the location of removed spalls.

*Figure 14. Removed spall at connection location. Note: connection is painted with blue colored coating.*

*Figure 15. Removed spall at connection location. Note: connection is painted with blue colored coating.*

1. Remove delaminated concrete at embedded plates, and clean and paint the plates. Proactively removing potential spalls at connection plates could be performed, but may not be necessary if the netting remains in place. If removing the netting is desirable, we recommend proactively removing potential spalls at embedded connections.
2. Repair concrete spalls with exposed reinforcing steel within the body of the precast member.
3. Repair deteriorated areas of grout.
4. Clean and paint the concrete with a coating system capable of bridging over cracks. Some cracks and joints may need to be stripe coated or sealed prior to the coating installation.

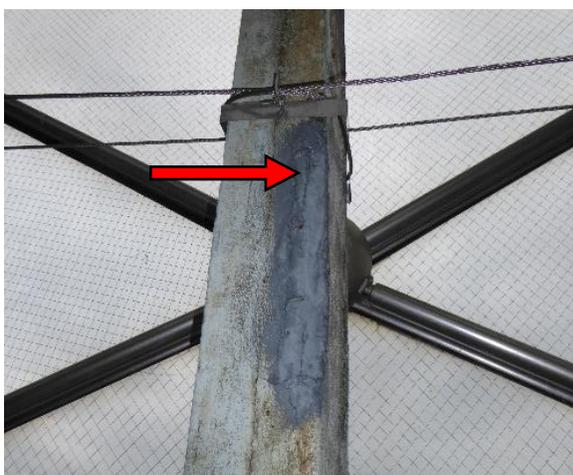
4. Concrete spalls, previously removed, were observed within the body of the precast concrete member, exposing reinforcing steel at a few locations in the Arid Dome (Figures 16 and 17). The reinforcing steel appeared to have minimal concrete cover.

*Figure 16. Removed spall within the body of the precast element. Note: concrete and reinforcing steel was painted with a blue colored coating.*

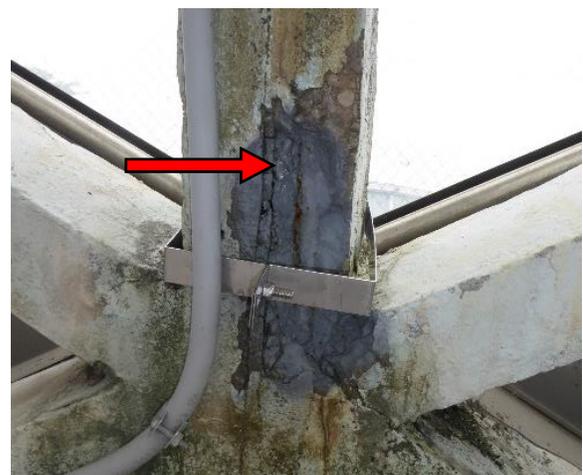
5. Missing grout was observed between precast members at a few locations (Figure 17).
6. Fine, transverse-oriented cracks spaced along the length of the precast members were observed at several locations (Figure 18). Cracks were typically highlighted by soiling and peeling paint.

*Figure 17. Removed spall within the body of the precast element. Note missing grout between precast members.*

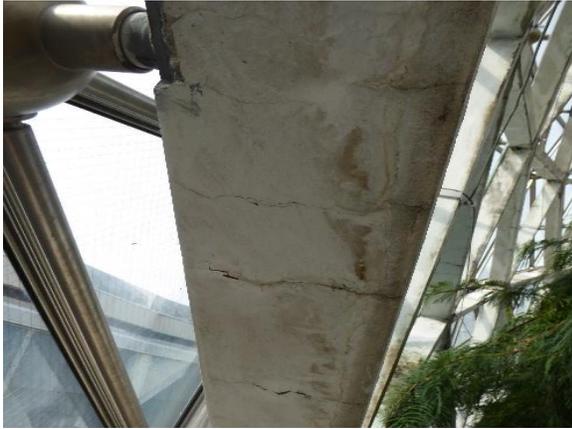
*Figure 18. Transverse cracks on precast member*

The cracks observed on precast members are not an indication of any structural deficiency and appear to be the result of concrete shrinkage and stresses associated with normal structural behavior. In their current state, the cracks will continue to open and close with temperature change. The drying shrinkage in this concrete has mostly taken place and is not a factor to cause further cracking. The cracks should be protected from moisture. GRAEF reported cracks between precast members, and between the concrete base and precast members. We suspect that the cracks were observed in the coating system at the joint between precast members and between the concrete base and precast members. The joint should be sealed during the installation of the new coating system.

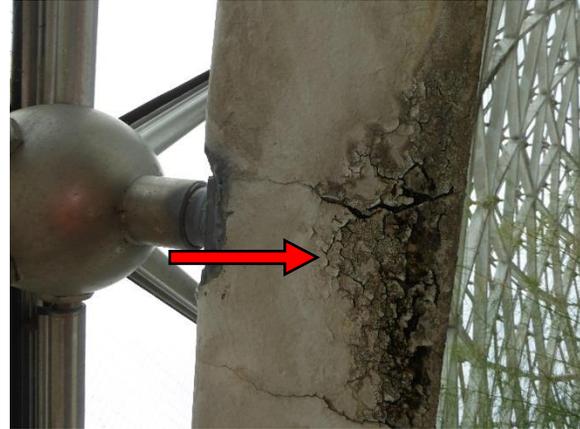
7. Cracked and peeling paint was observed on most precast members (Figure 19).

*Figure 19. View of cracked and peeling coating on precast member*

- We recommend that the following characteristics be considered with the selection of a coating system: concrete carbonation protection, waterproofing, and aesthetics. The recommended coating systems by GRAEF for the precast concrete include an epoxy system and a stain. The stain will not be able to bridge cracks in the concrete and we do not recommend that a stain be installed. We recommend that further research be performed by GRAEF to understand the crack bridging capabilities of the proposed epoxy system. An epoxy system may fade and degrade slowly due to ultraviolet exposure, but could be beneficial to seal the concrete from oxygen depending on future corrosion potential due to the existing concrete carbonation depth and operating environment. A breathable acrylic or acrylic elastomeric coating could also be considered for the precast concrete members. An elastomeric coating will provide good crack bridging capabilities, but may not bond well in a humid or damp environment. A different coating system could be considered for each dome depending on the interior environment. Surface preparation and removal of the existing coating system may prove very difficult due to access and protection. Therefore, we recommend trial installations, bond testing, and evaluation of different coating systems and surface preparation techniques.

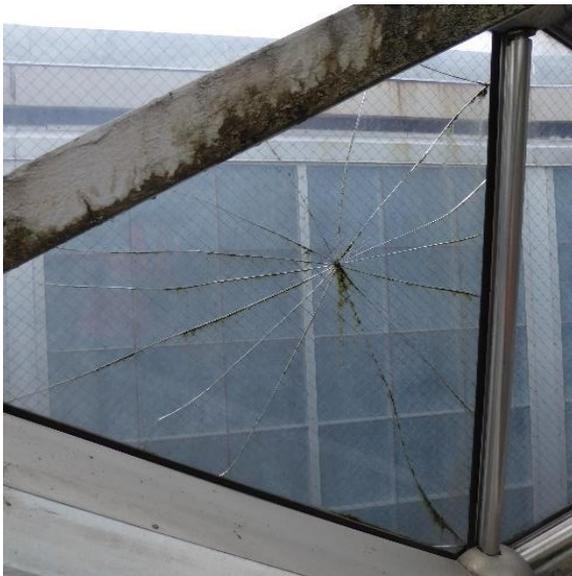
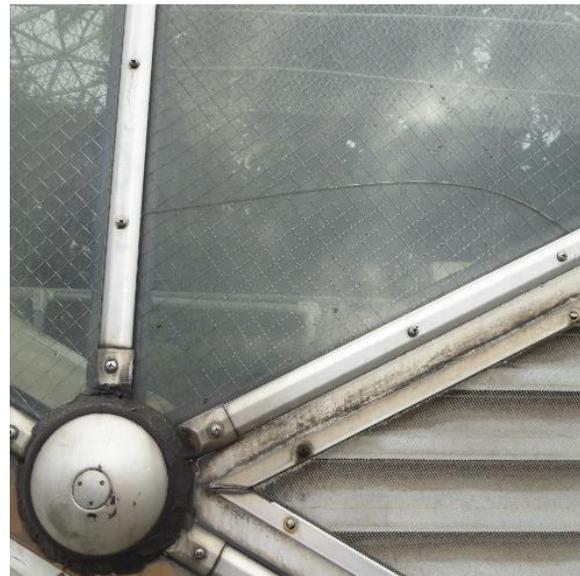
1. Cracked glass units were observed at several locations (Figures 20 and 21). Some of the cracked glass appears to be the result of impact.
2. The glazing material that separates the glass from the pressure caps has deteriorated over time. This is a likely source of water infiltration into the domes (Figure 22).
3. Sealant was installed around the hubs at several locations at the base of the domes (Figure 23).
4. Leakage was observed at approximately six locations in the Arid Dome at the connection of the hub to the downspout rafter. At locations where leaks were observed, the downspout rafter fitting had visible black material build-up, which seems to be an indicator of a leak location (Figure 24).

*Figure 20. Cracked glass, likely from impact*

*Figure 21. Cracked glass*

The primary issues with the cladding appears to be glass breakage and water infiltration. Some glass breakage appears to be related to impact while other locations may be related to thermal movements. The glass is wire reinforced. If broken, wire reinforced glass is not normally considered a falling hazard, since the wires engage the broken glass and inhibit broken glass pieces from falling. The glass framing has a drainage system that collects incidental water, either due to occasional rainwater leaks or internal condensation. GRAEF had indicated that water was observed sitting in the hub and not allowed to drain, which is likely the reason why water currently leaks out at the hub locations. In WJE's opinion, this condition is a result of the original design of the drainage system which set the opening in the downspout rafter slightly higher than the hub. We believe that this condition can be repaired (see our following Recommendations section).

- The wired glass can remain as is, unless it is broken; in which case it should be removed and replaced. Full replacement of the wired glass is not required for safety reasons. At locations where the wired glass is broken, WJE recommends replacement in-kind or with laminated glass. Laminated glass will have a change to the cladding's appearance.

1. Replace existing cracked and broken wired glass in kind, or with laminated glass. Modifications in the glass replacement design could be implemented based on the findings from further investigation and mock-up repairs.
2. Remove and replace all pressure caps and wet seal joints (Figure 25).
3. Clean hubs and install self-leveling sealant at leading hubs (Figure 26).

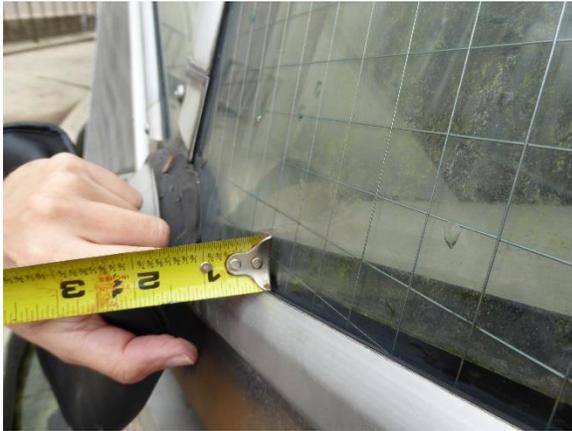
*Figure 22. Glazing material at pressure cap on glass cladding*

- For weather protection, WJE would normally recommend resealing the glass to aluminum joints around the dome. This is usually performed by a "wet seal" between the glass and the exterior aluminum (the pressure cap). In this case, however, the edges of the existing pressure caps are thin. Obtaining an adequate wet seal joint between the pressure cap and glass would be difficult. As an alternative, removing and replacing the pressure cap with a new redesigned pressure cap would allow for additional weather protection by: a) replacing the exterior glazing seals between the glass and the pressure cap with new glazing seals, and b) a thicker edge detail on the new pressure cap, which would allow a wet seal to supplement the new glazing seal. We believe that this redesign would largely resolve rain water leakage through the dome. We believe that this is a practical step for GRAEF to consider as an addition to their Option 1 repair.

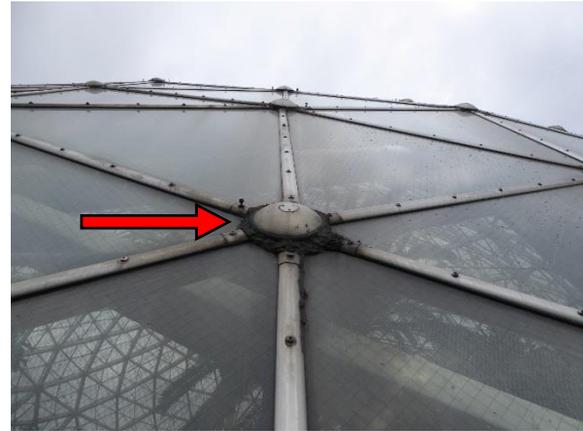
*Figure 23. Sealant installed around hub of glass cladding*

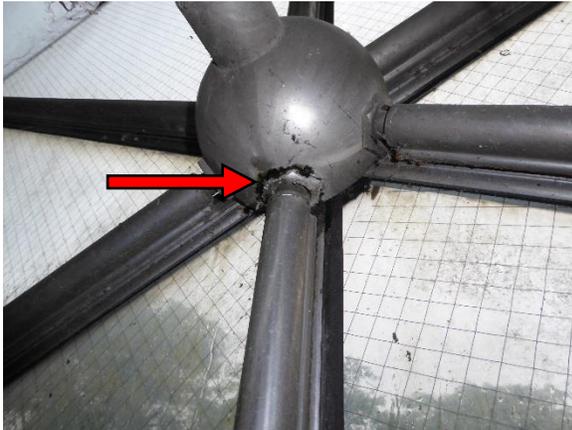
*Figure 24. Black build-up on downspout rafter fitting at water leakage location*
