**MITCHELL PARK HORTICULTURAL CONSERVATORY  
DOMES  
Peer Review**

**Milwaukee, Wisconsin**

**Final Report**

WJE No. 2016.2700

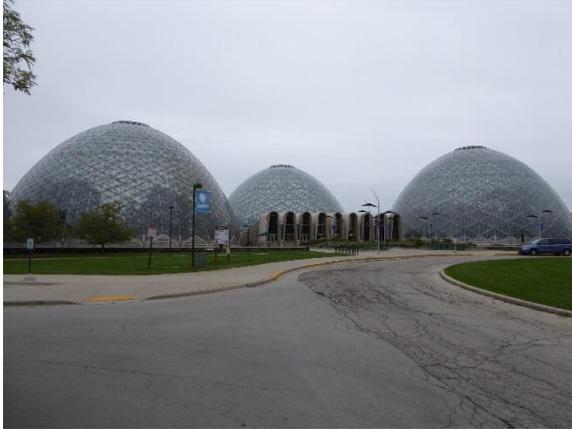
Figure 1. Overall view of the domes

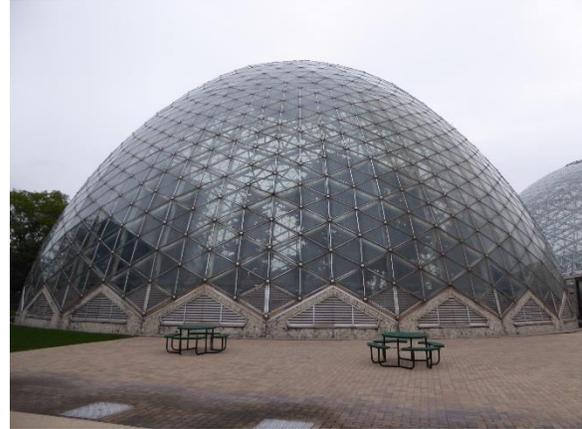
Figure 2. View of the Show Dome

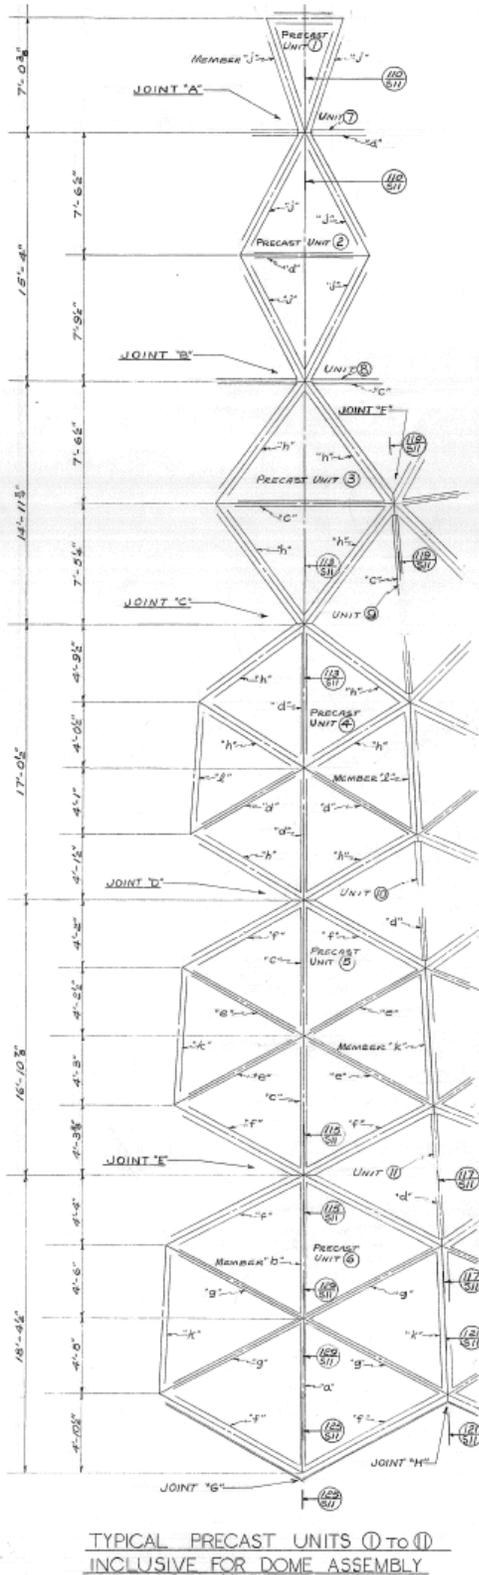
5. The precast concrete frame is comprised of eleven space frame member types (Figure 3). The assembly repeats around the domes 25 times.
6. Precast concrete members are trapezoidal, with the width at the top of each member typically 1/2 inch wider than at the base.

Figure 3. Typical precast concrete members - reproduced from original drawings

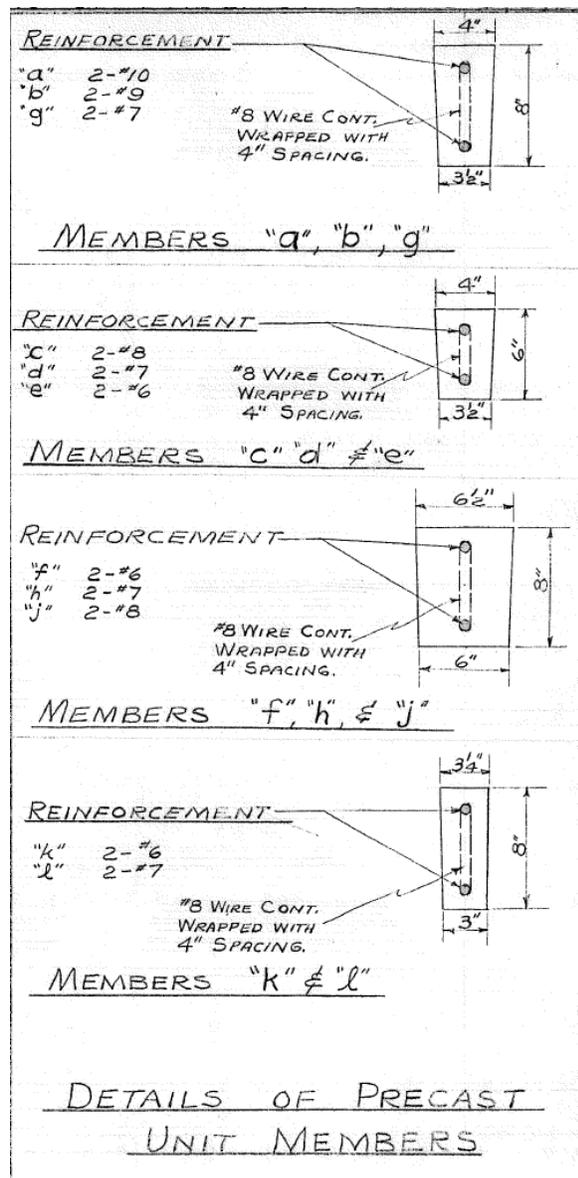
7. Precast concrete members vary in size from a width between 3 inches and 6-1/2 inches, and a depth of 6 or 8 inches (Figure 4). Precast members are reinforced with two longitudinal bars, one each at the top and bottom of the member. The size of the reinforcing bars range from No. 6 to No. 10 bars. The side concrete cover is over 1 inch on smaller members and approximately 2-1/2 inches on larger members.

Figure 4. Details of precast concrete members and reinforcing - reproduced from original drawings

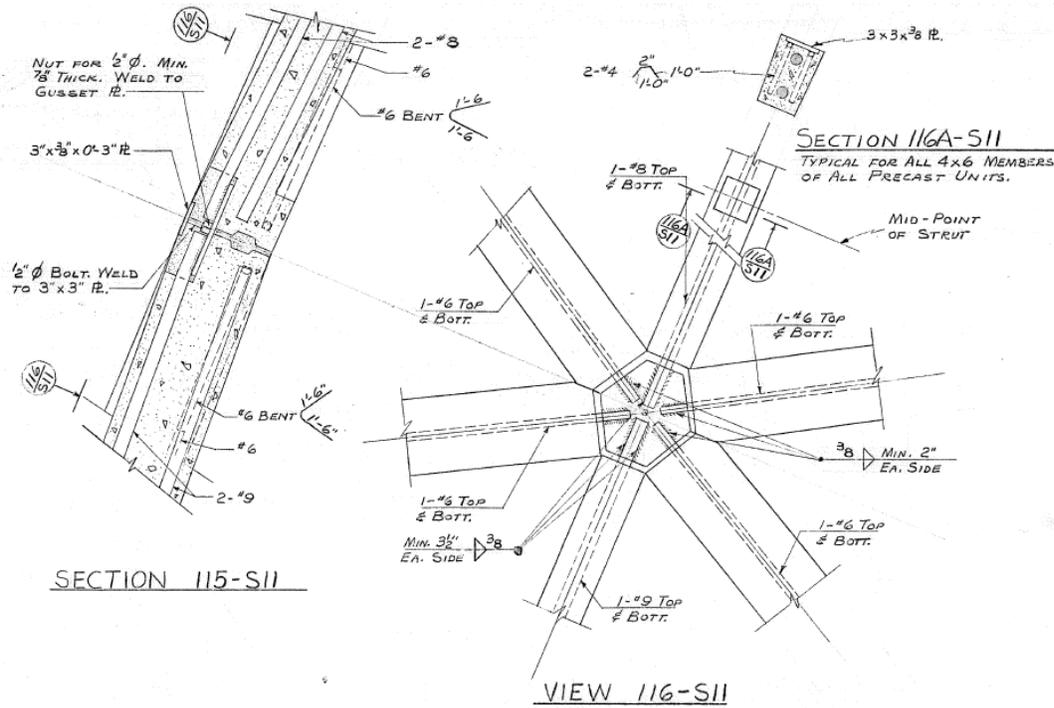
DETAILS OF JOINT "E" (JOINT "D" SIMILAR)  
SCALE: 1/2" = 1'-0"

8. Precast concrete members are attached together at joints by welding the end of reinforcing bars in the precast to a gusset plate (Figure 5). Grout is installed over the plate and into the keyway between the precast members.

Figure 5. Typical precast concrete member connection at joint - reproduced from original drawings

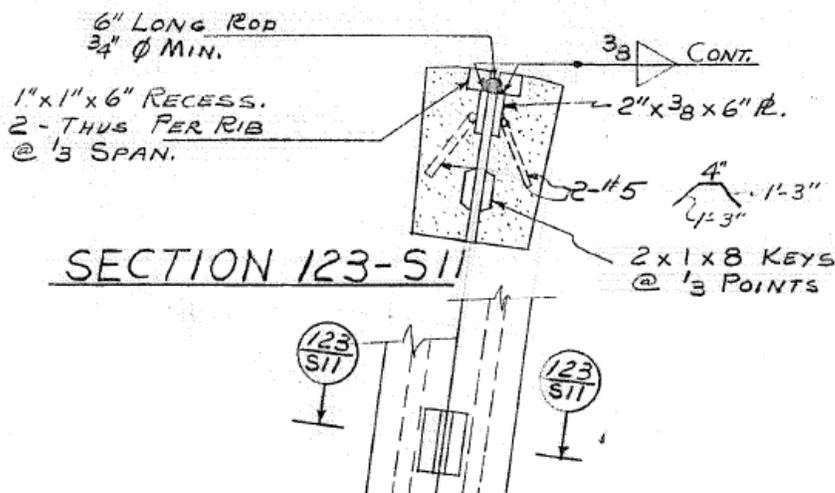
9. Adjacent precast concrete members are attached together by welding a 6 inch long, 3/4 inch diameter rod between embedded plates in each member (Figure 6).

Figure 6. Typical precast concrete connection between members - reproduced from original drawings

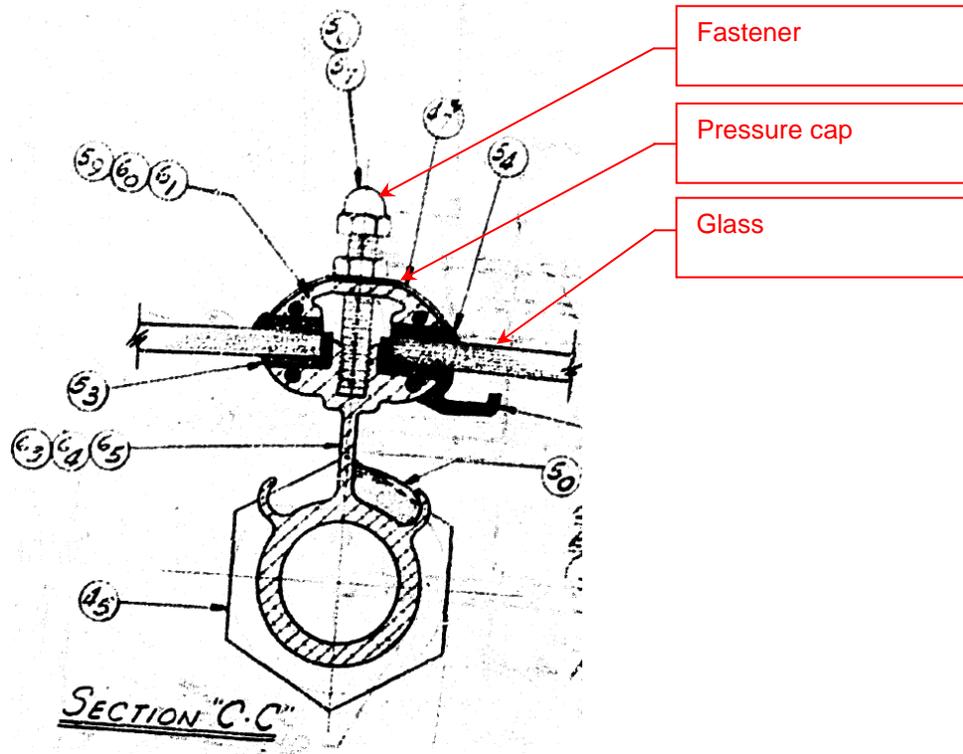
10. The glass is specified to be 1/4 inch patterned wired glass manufactured by the Mississippi Glass Co., St. Louis, Missouri.
11. The glass is held in place with a pressure cap and fasteners (Figure 7).

Figure 7. Section through glass and aluminum frame

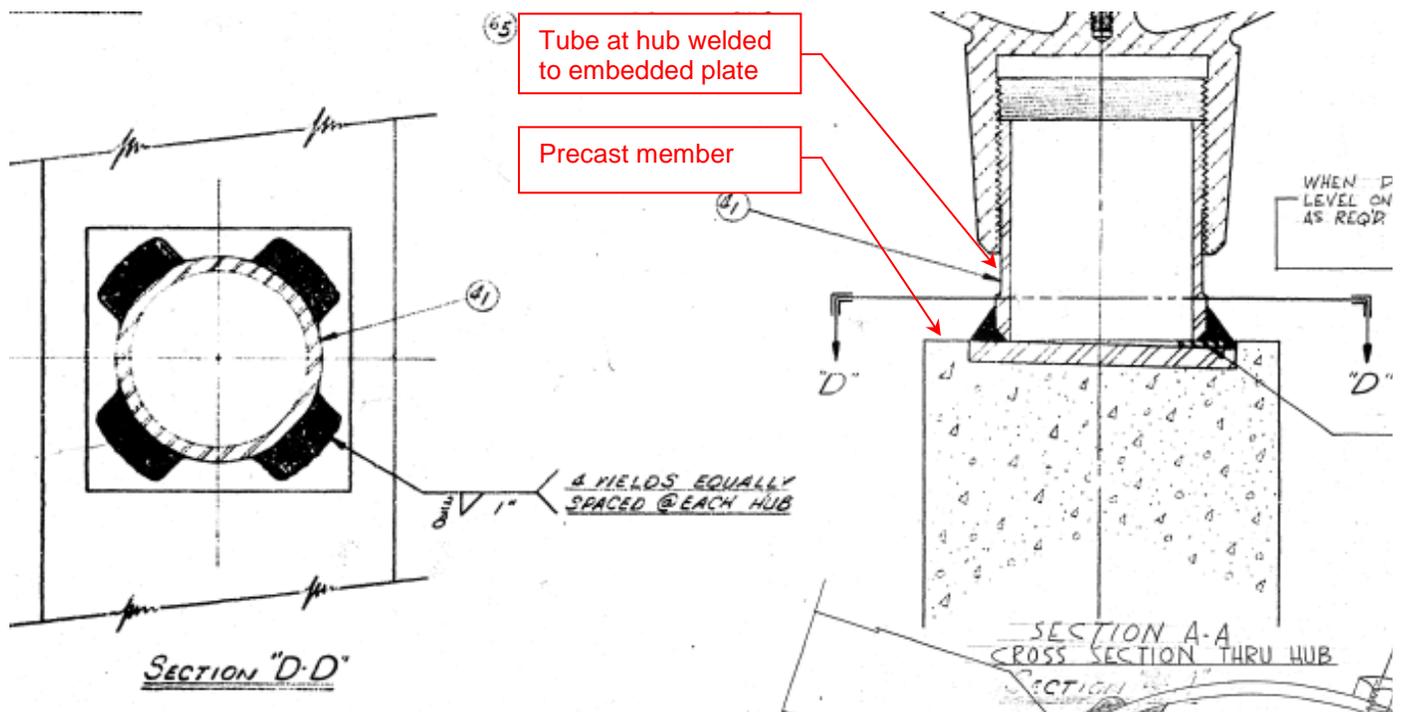
12. The circular hub is welded to an embedded plate in the precast concrete members (Figure 8). The embedded plate in the precast members is flush with the surface of the concrete.

Figure 8. Section through hub from original drawings showing hub welded to embedded plate in precast concrete member
